DURABILITY OF CULVERT PIPE

Jas. H. Havens  
Director of Research

Division of Research  
DEPARTMENT OF HIGHWAYS  
Commonwealth of Kentucky

August 1968

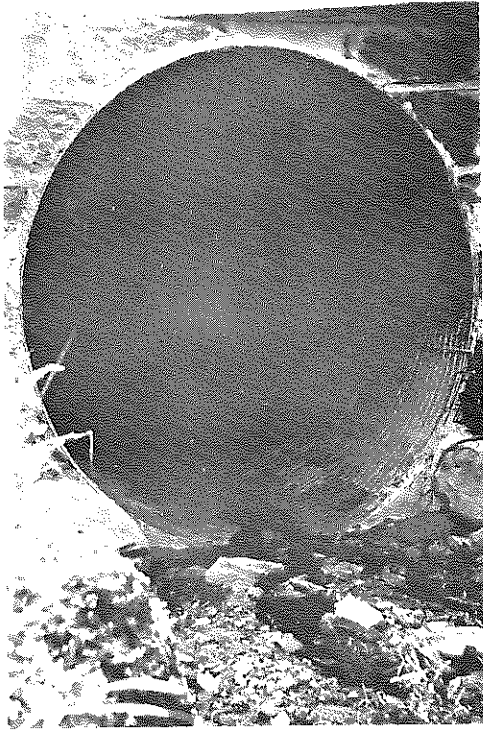
The first BCCM pipe in Kentucky was installed 5.8 miles east of Jackson, KY 15, near Haddix, in 1928. An existing masonry, box culvert with a concrete slab roof was failing. An 84-inch diameter, full-coated, paved invert, one-dip pipe was threaded into the existing box in the fall of 1928. Figure 1 shows the pipe soon after installation. Saunders Threlkeld (Junior Materials Engineer), reporting on a group inspection, July 14-16, 1941, noted some loss of coating at the outlet. Figure 2 shows the culvert as it was in October 1951. The coating was quite shrunken, and some was missing in the lower half, nearest the ends. The water was found to be altogether inoffensive. KY 15 was reconstructed in 1967.

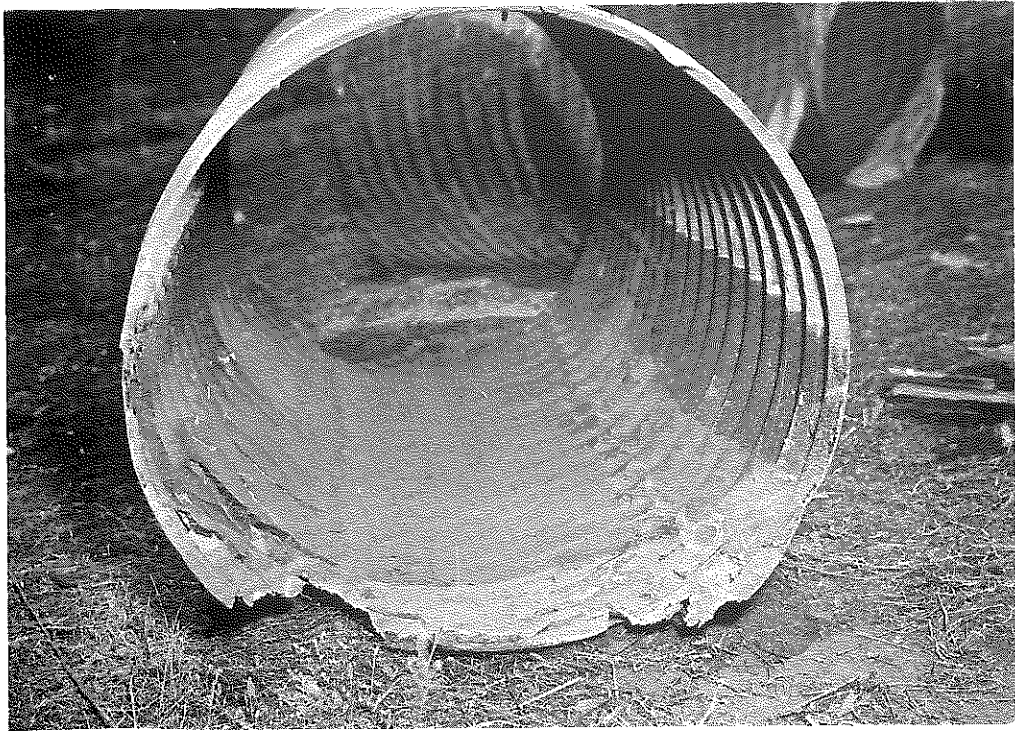
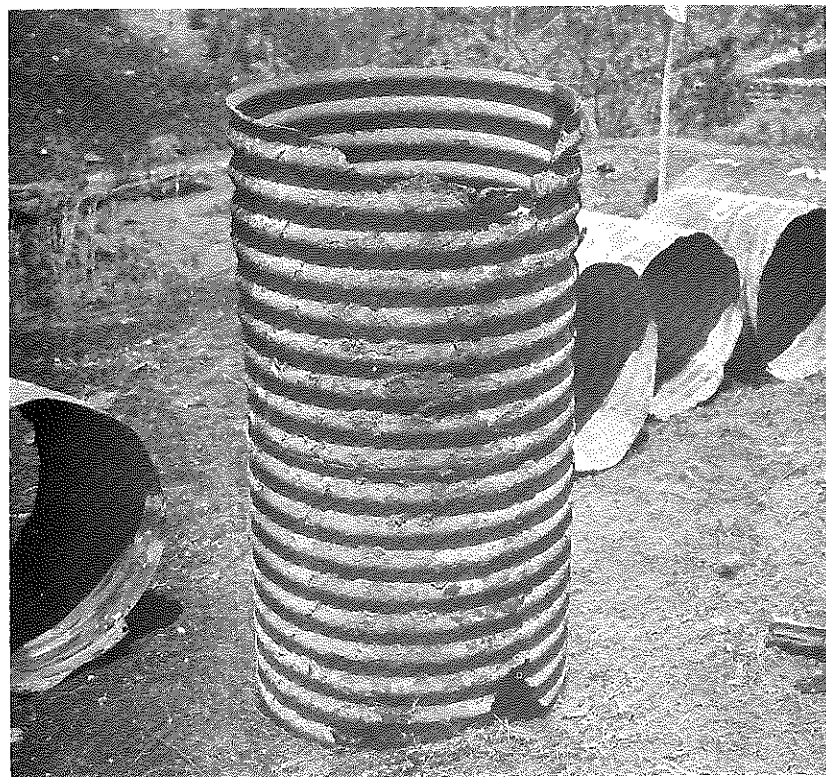
These two pieces are declared terminal; their companion pieces and all other types of metal pipe originally installed (1951) were taken out of test previously.

Figures 3 and 4 show the half-coated and paved piece, April 1968.

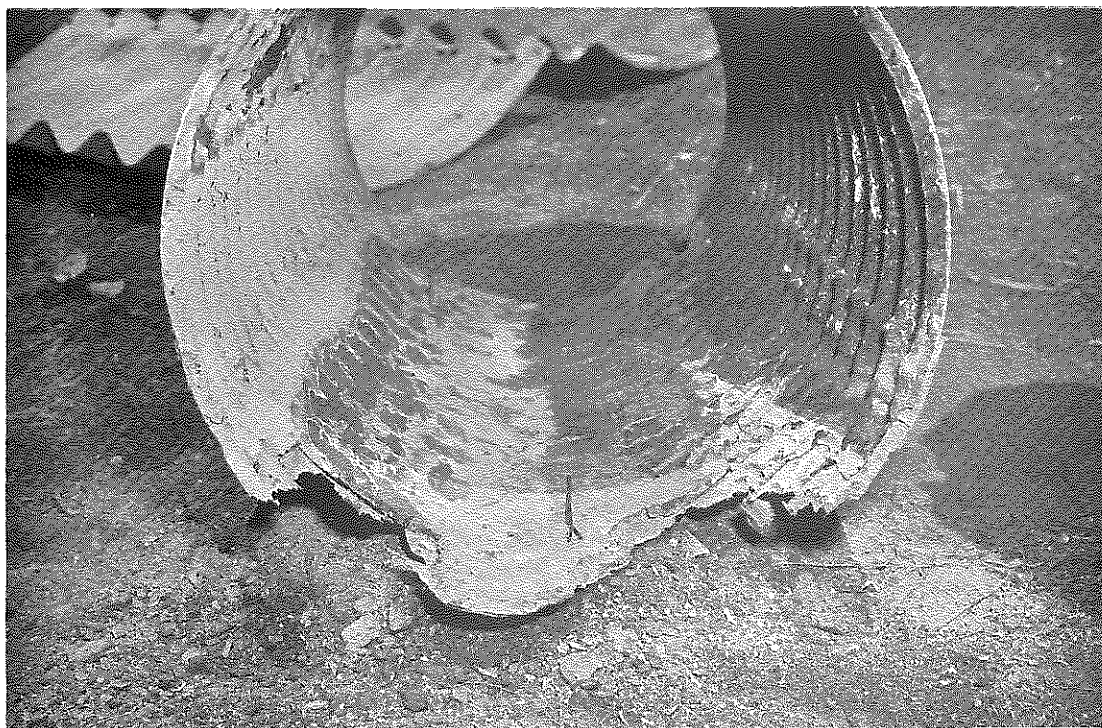
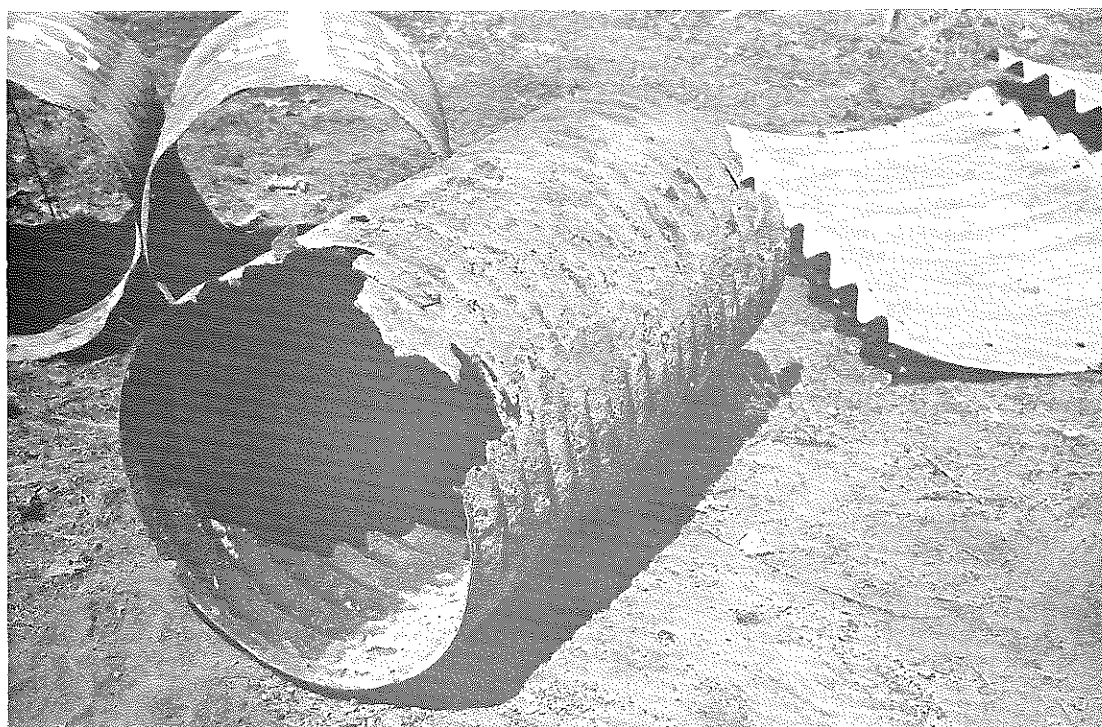
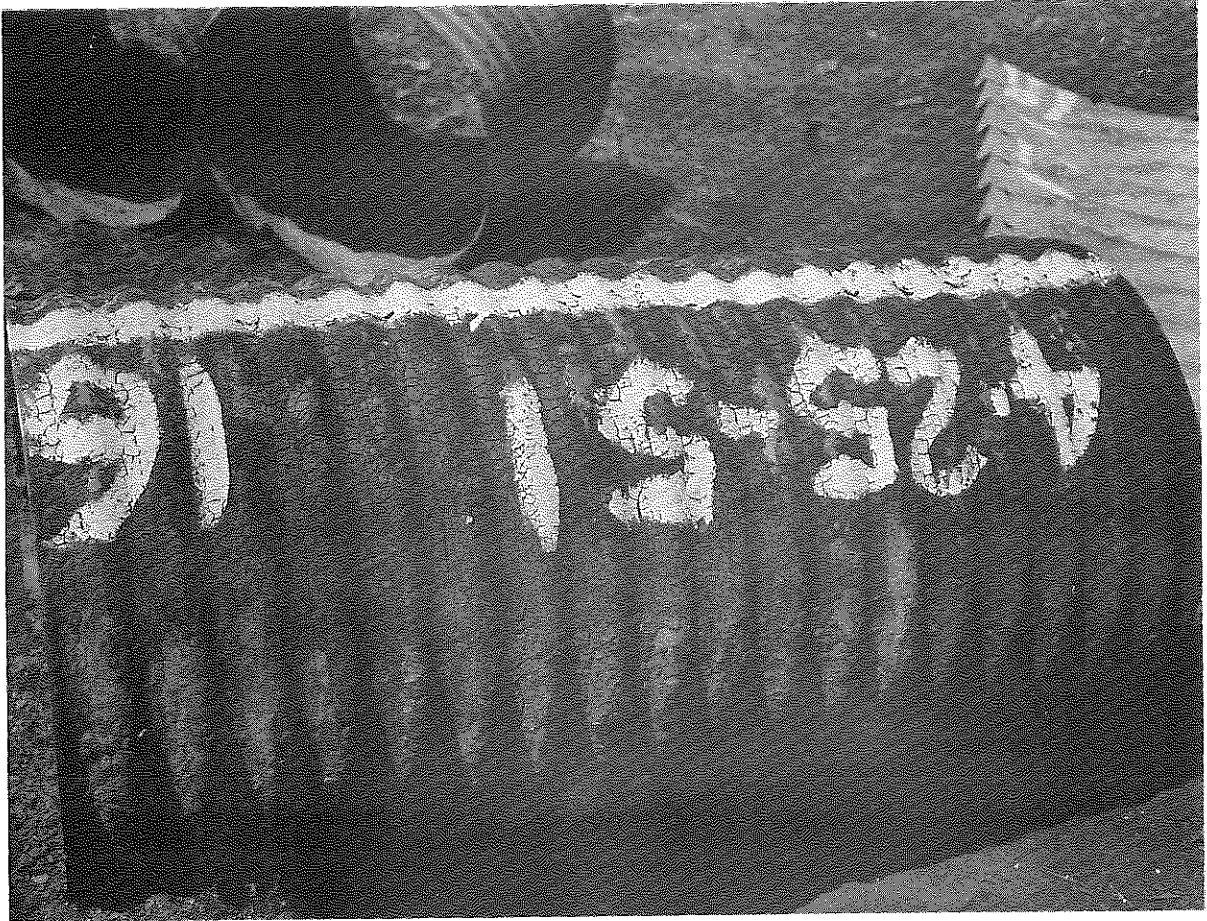
Figures 5, 6 and 7 show the full-coated and paved piece, April 1968.

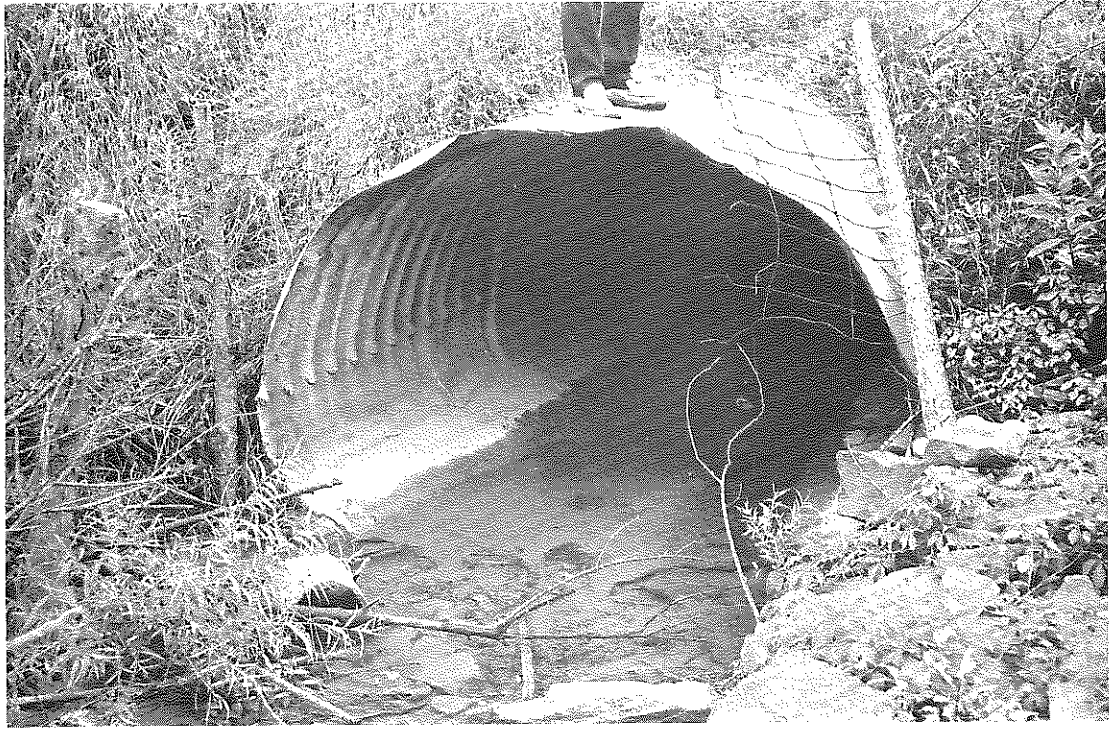
Figure 8

3. 4.0 miles, uncoated pipe-arch with concrete or Gunitite paving; reported to have corroded through the bottom before the road was completed; pH 4.5.
4. 4.8 miles; at Lost Creek school; multiplate arch, 93 x 64 inches, uncoated, Gunitite paving (see Figure 8).

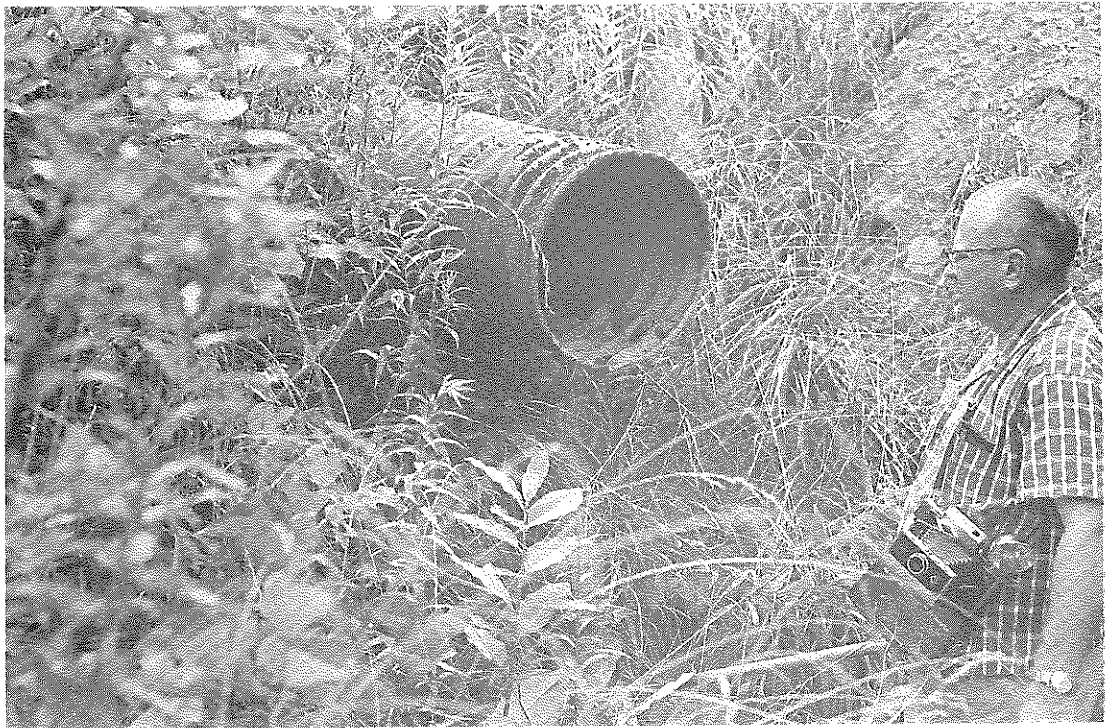
Figure 9

5. 5.25 miles; 36-inch BCCM pipe; partly filled, evidence of corrosion; pH 5.0.
6. 5.75 miles, 18-inch, BCCM pipe; coating missing at outlet, metal perforated; abandoned mine site above the road (see Figure 9).

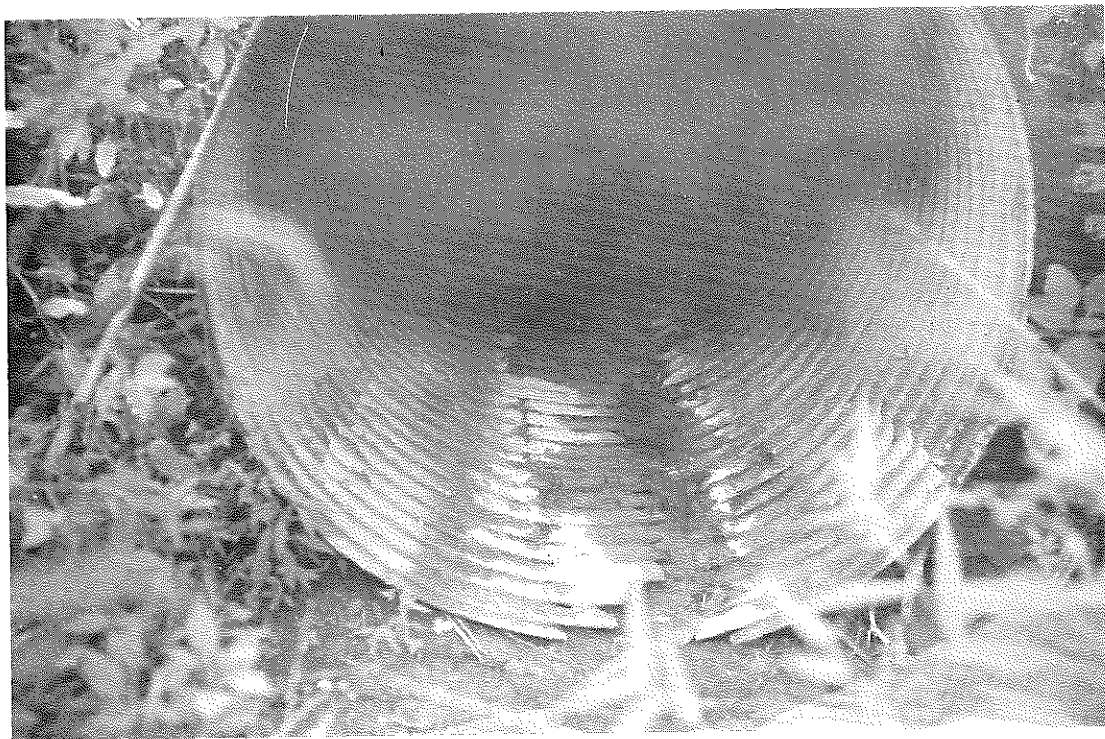
Figure 10

7. 5.60 miles; 48-inch, BCCM pipe; flow line corroded away; drains former mining area; pH 4.0 (see Figure 10).
8. 5.85 miles; 18-inch, BCCM pipe; outlet corroded about an inch inward; pH 4.5.

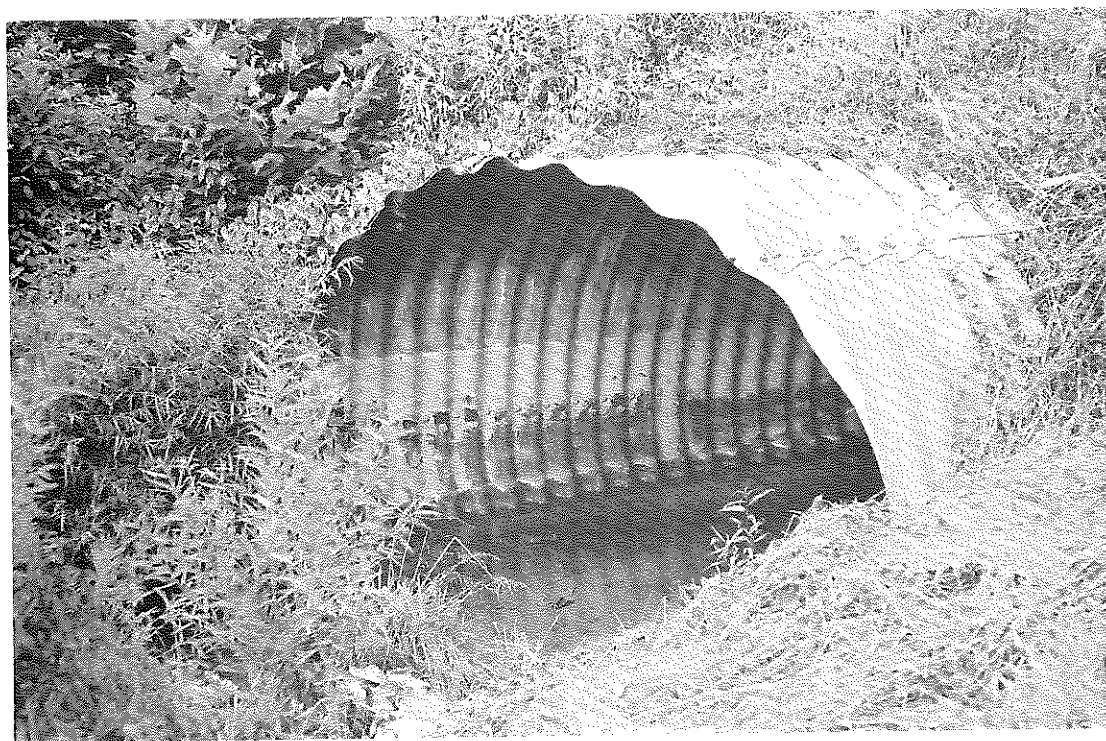
Figure 11

9. 5.9 miles; 18-inch, BCCM pipe; bottom corroded for several feet inward; pH 4.5.
10. 6.1 miles; 64-inch multiplate arch; uncoated; rust showing on sides; bottom silted; pH 5.5 (see Figure 11).

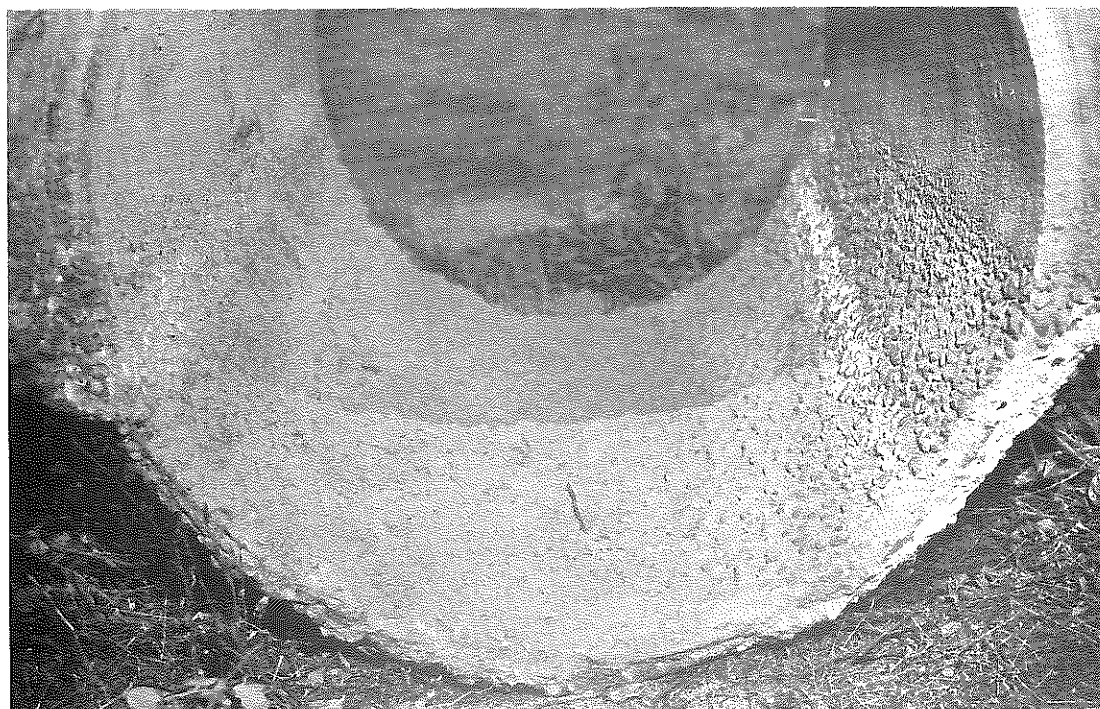
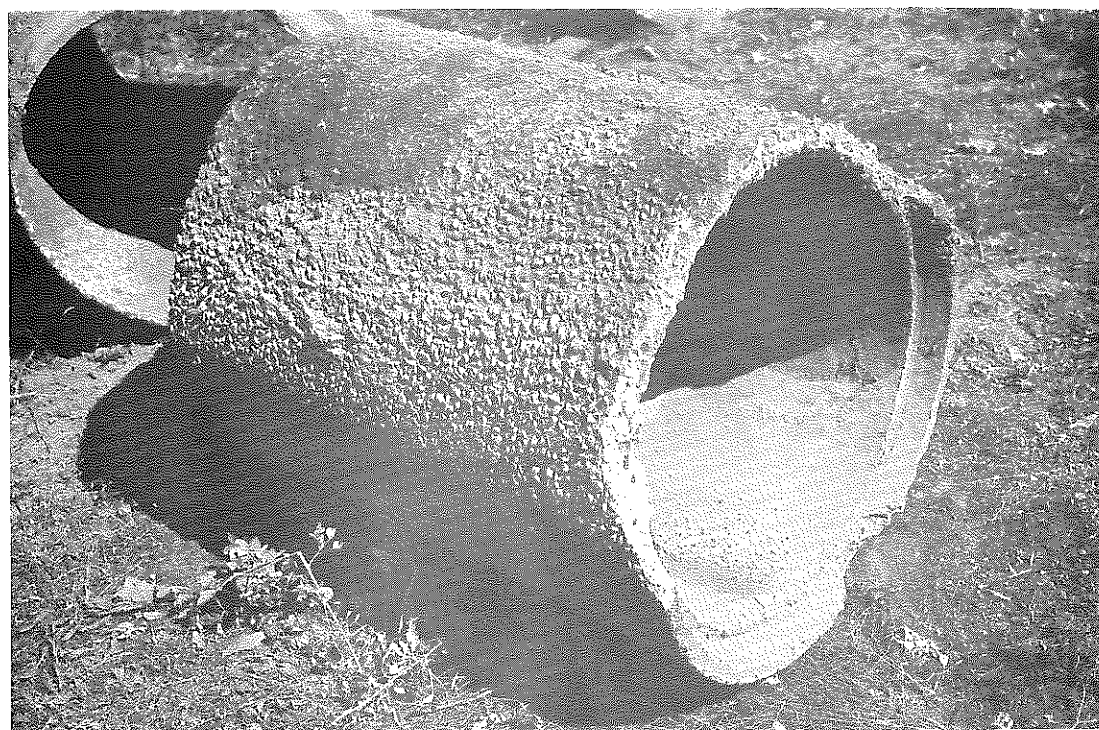
It is appropriate perhaps to record here the basis for declaring RC pipe at the Mortons Gap test site as being now terminal. Figures 12 and 13 show the present condition of the RC pipe (gravel aggregate) put into test in April 1951. Figures 14 and 15 show RC pipe manufactured with limestone aggregate and which was put into test September 21, 1954.

The pH there has ranged between 3.5 and 2.8.
